CONTEMPORARY GEOTECHNICAL ISSUES ASSOCIATED WITH HISTORIC MINING

Matthew Oakley

- Brief review of historic mining
- Overview of contemporary geotechnical hazards
- Methods of investigating historic workings
 - **Broomshields Avenue** - subsidence
 - **Throckley** – development above opencast and mine shafts
- Remedial techniques
 - **Throckley** – gas membrane
 - **Anfield Plain Grouting** – grouting of worked seams

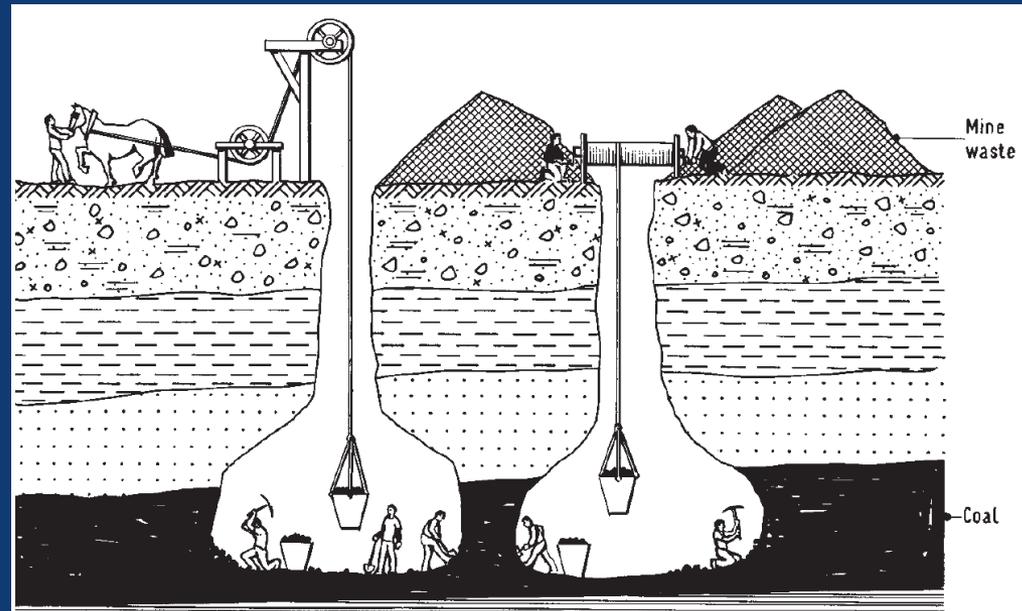
BELL PITS

- Bell pits employed primitive mining techniques, in which a shaft was sunk to the depth at which the coal was found and miners excavated outwards.
- Bell pits often flooded due to the lack of drainage and this, together with the lack of supports and the inevitability of collapse, meant they had a limited lifespan.

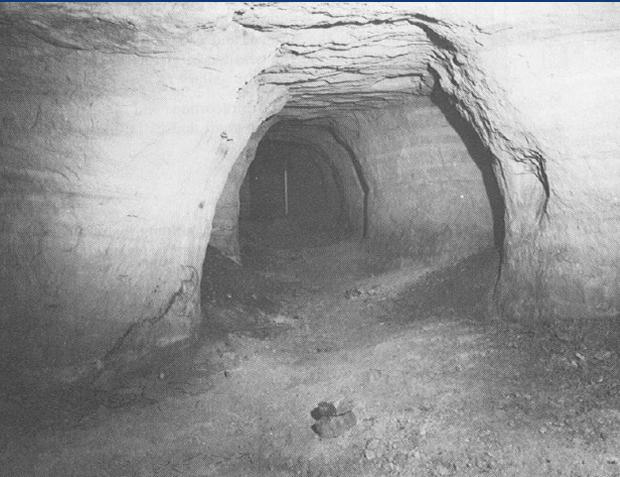
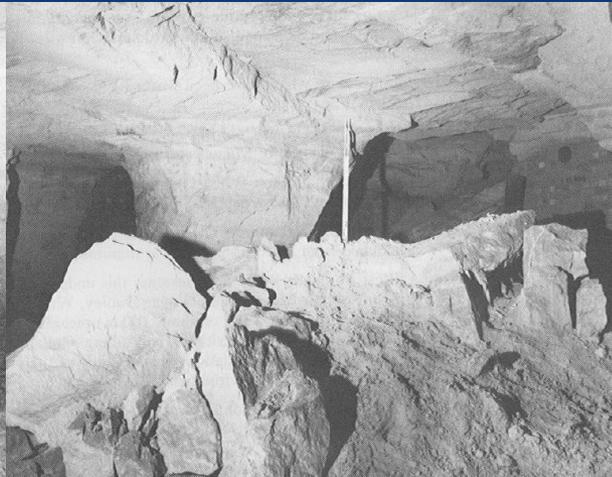
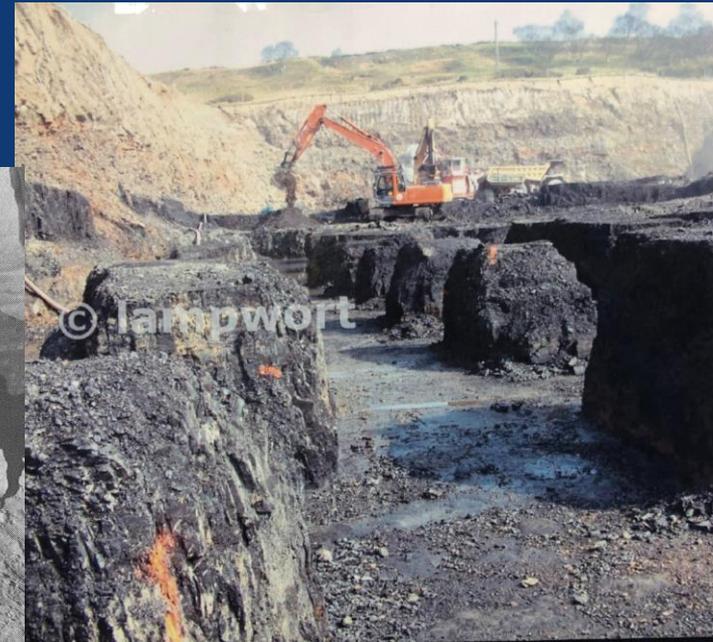
ROOM AND PILLAR

- A mining system in which the material is extracted across a generally horizontal plane, creating horizontal arrays of rooms and pillars.
- To do this, "rooms" of ore are dug out while "pillars" of untouched material are left to support the roof overburden.

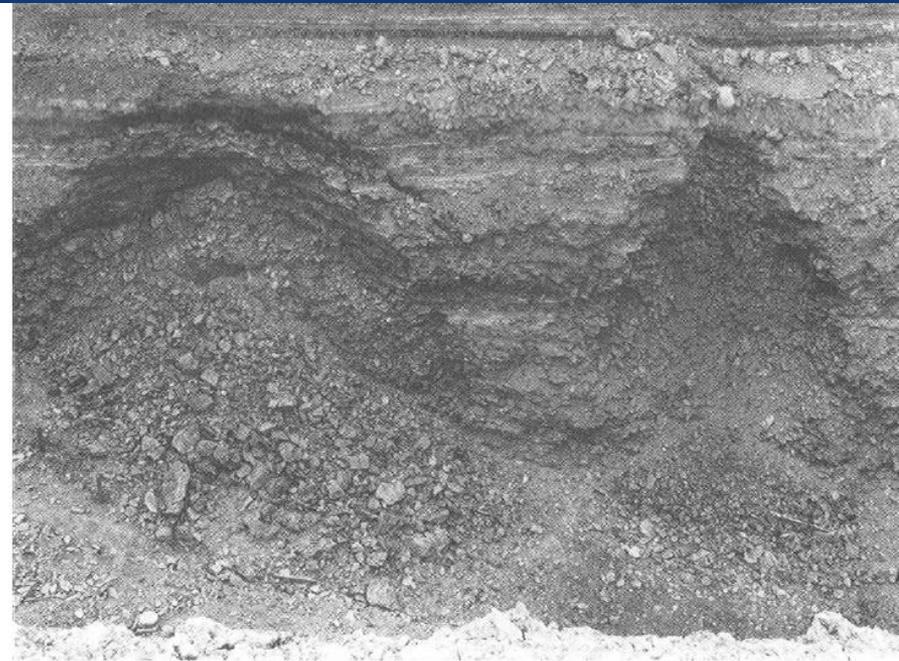
Figure 14
Long-term conical void migration in weathered Coal Measure rocks from old mine workings (courtesy West Yorkshire Metropolitan County Council)

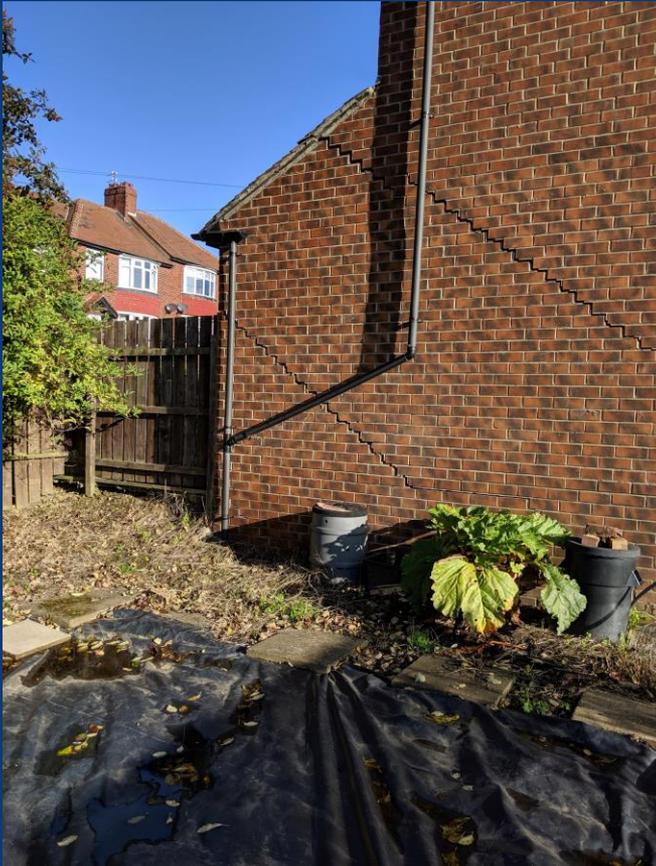
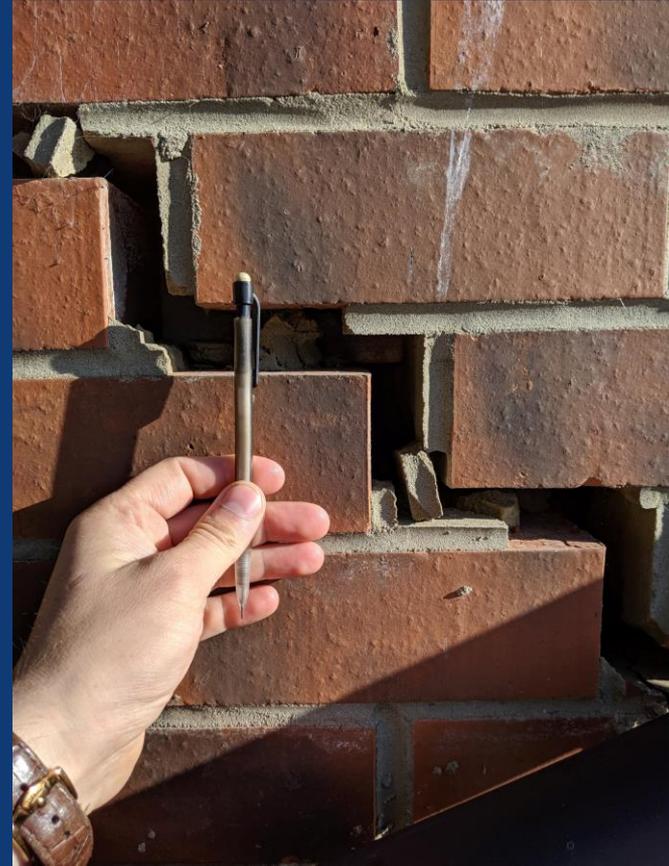
BROOMSHIELDS AVENUE, SUBSIDENCE

- Dunelm attended site which had undergone significant, >250mm, instantaneous subsidence.

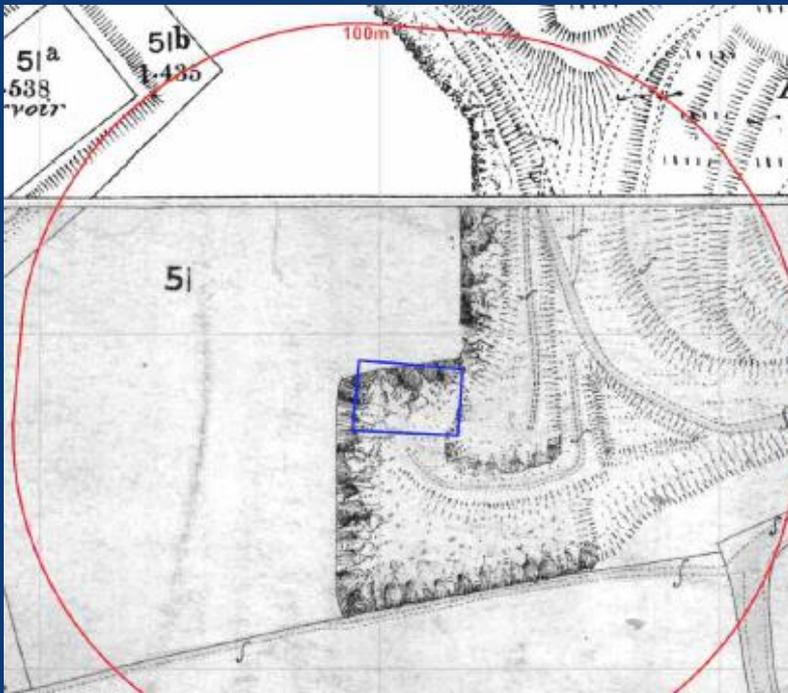
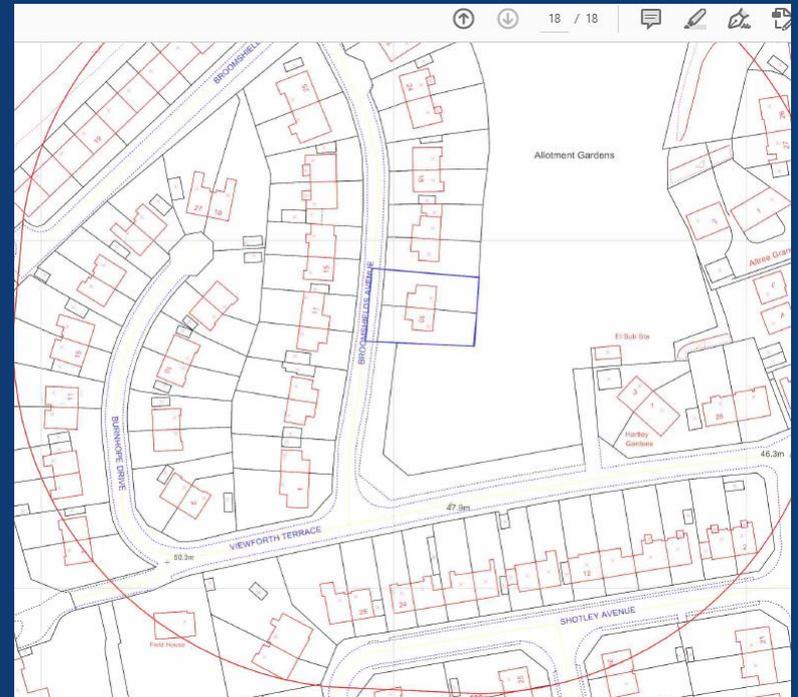
DESK STUDY FINDINGS

- Broomshields Avenue was built running along the highwall of a infilled limestone quarry.
- Anecdotal evidence suggests that plots to the west of Broomshields avenue have no historic issues, and plots to the east have significant issues associated with settlement.

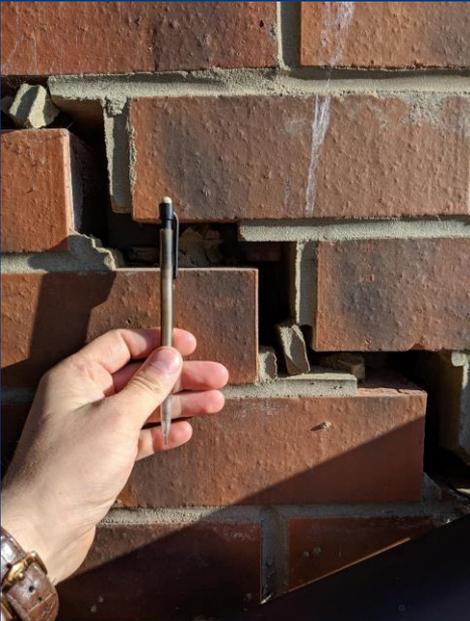
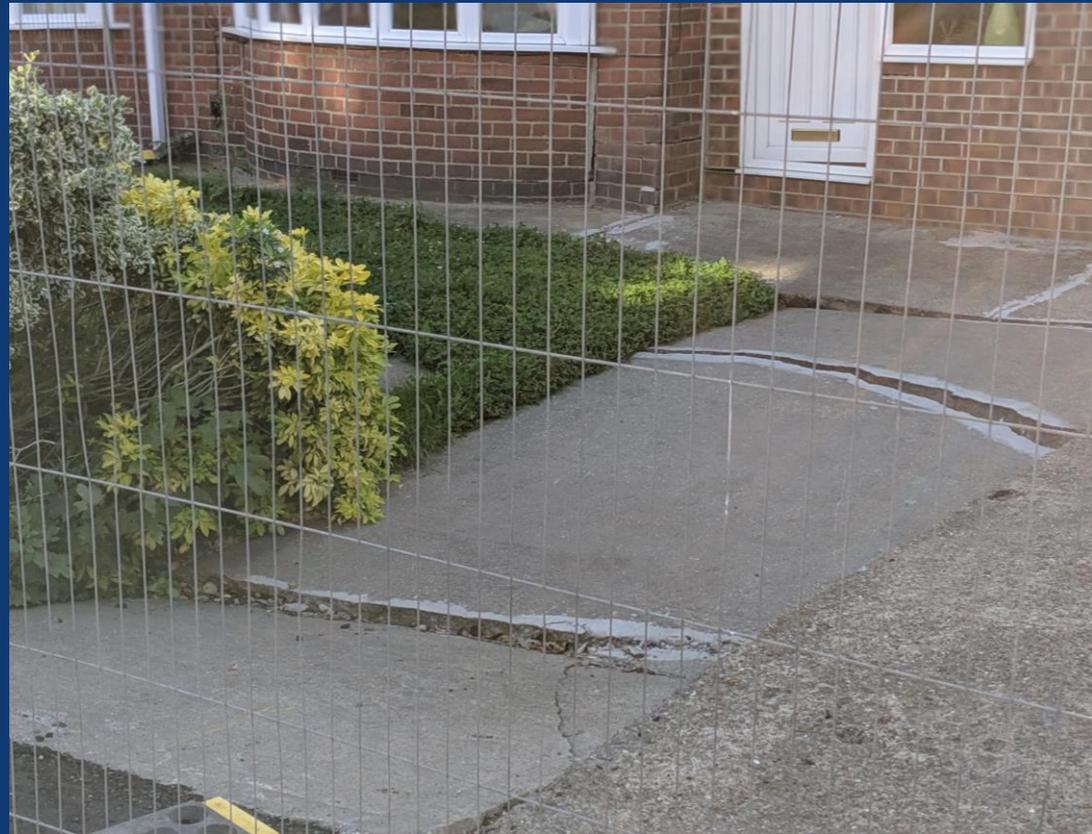
STRUCTURAL DAMAGE

- Significant structural damage and subsidence, $>200\text{mm}$, to residential properties and public roadways.

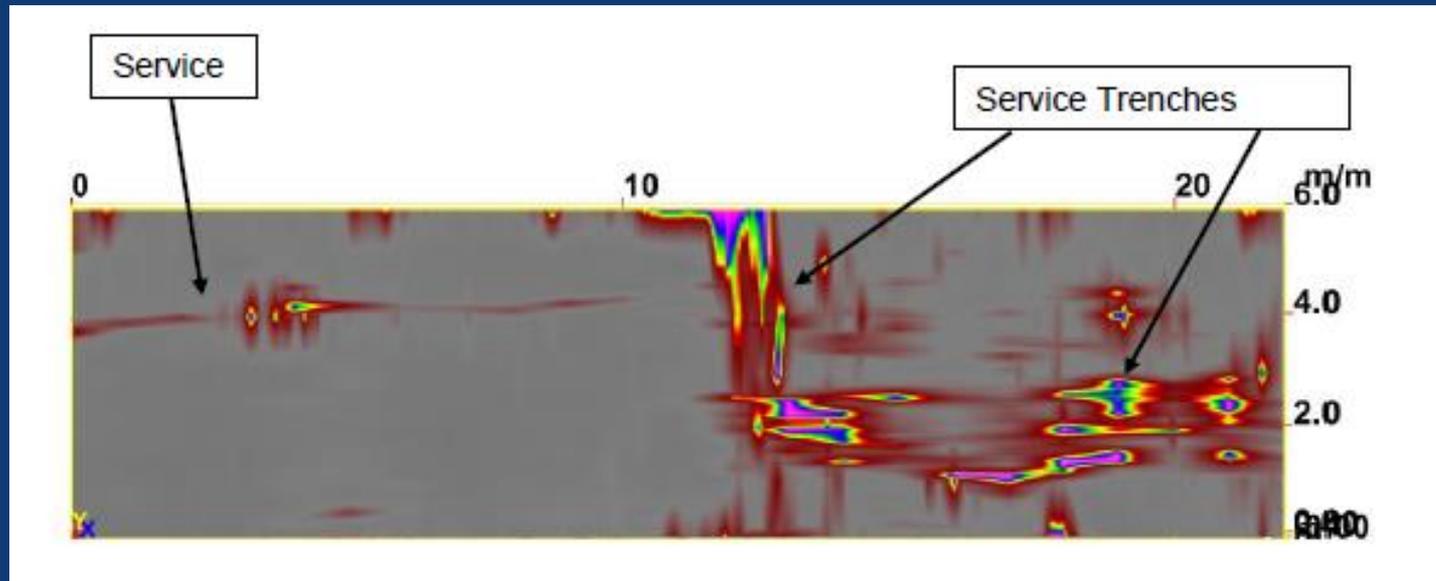
GEOTECHNICAL INVESTIGATION

- Shallow GRP survey to identify possible undetected near surface voids. The radar results were limited with a maximum signal depth penetration of approximately 1.0 meter with the 300/800Mhz antenna. No unanticipated voids identified.
- Exploratory boreholes to identify nature of underlying deposits

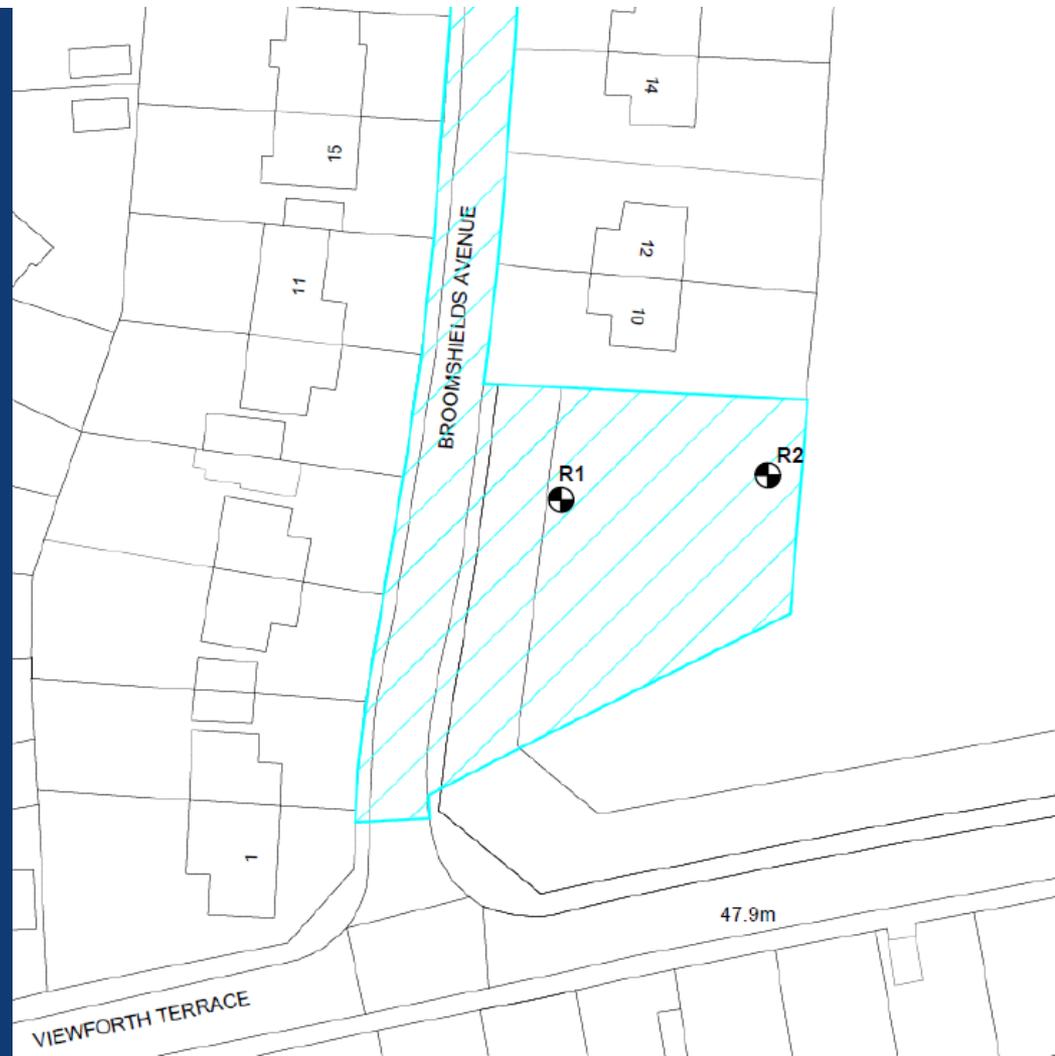
EXPLORATORY BOREHOLES

- 2 No. rotary boreholes were advanced using dynamic sampling with rotary follow on.
- Boreholes encountered made ground to a depth up to a depth of 17.3m bgl.
- The made ground generally consisted of granular material including brick, wire, wood and concrete between 0.15m and 3.7m bgl underlain by suspected quarry backfill.

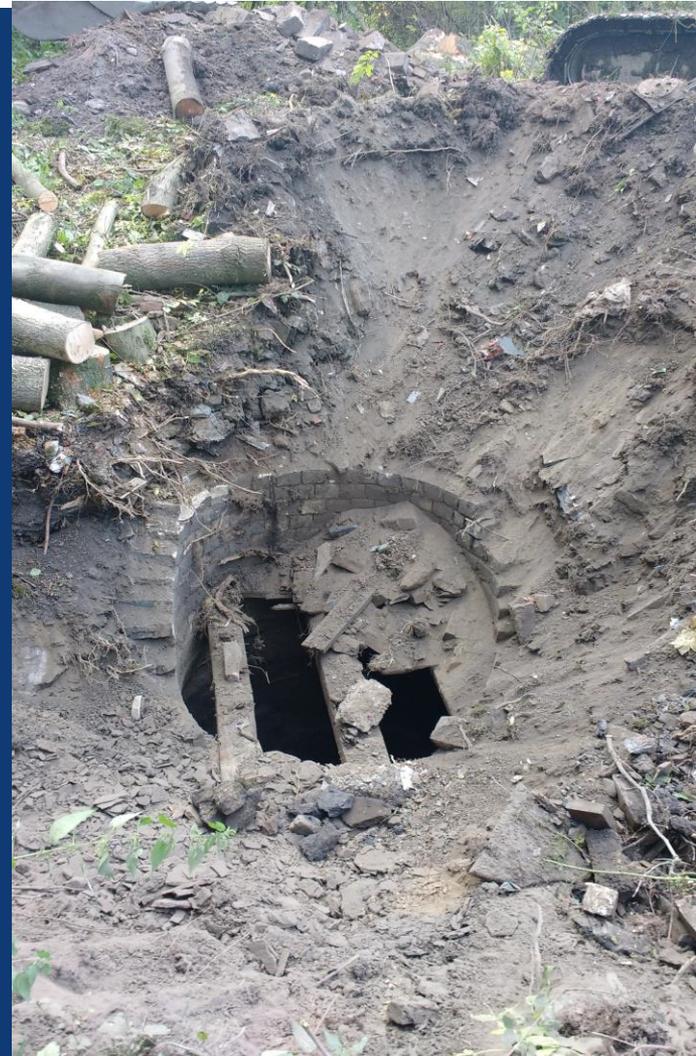
THROCKLEY – HOUSING DEVELOPMENT

- Proposed development was located above the Three quarters, Tilley and Top busy seams.
- Nine recorded mineshafts are recorded within the development boundary.
- An opencast was located running east to west across the centre of the site.
- Multiple phases of ground investigation.

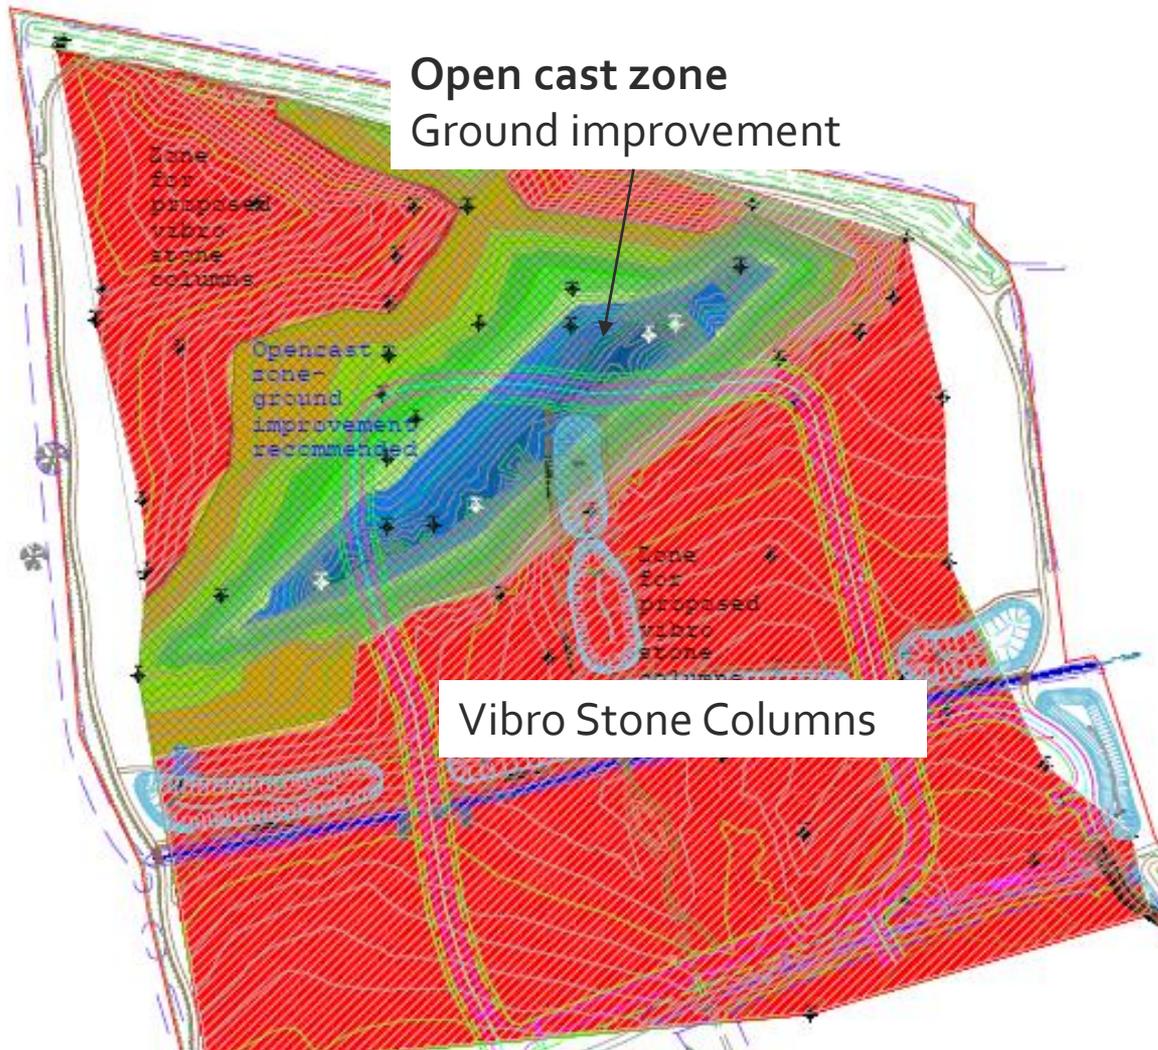
FOUNDATION SOLUTION

- Made ground up to 23.5m recorded in opencast.
- Ground improvement techniques where the made ground is greater than 7m.
- Where made ground is <7m deep in the north and south of the site, full depth vibro stone columns .
- Trench fill in the east of the site where made ground is <2m.
- Grouting of 3 worked seams beneath the site.
- Foundation is to incorporate a gas resistant membrane and a ventilated sub floor void.

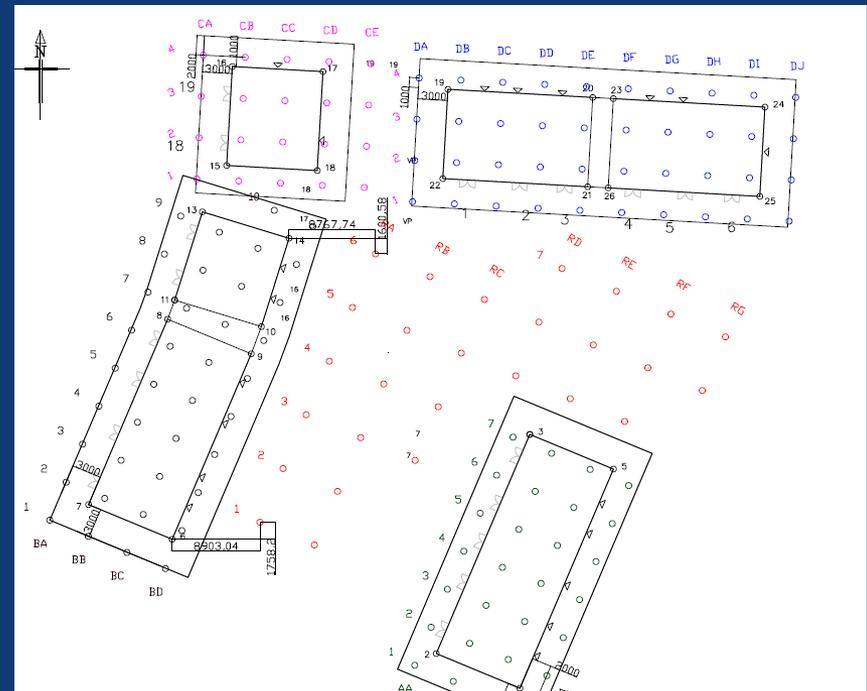
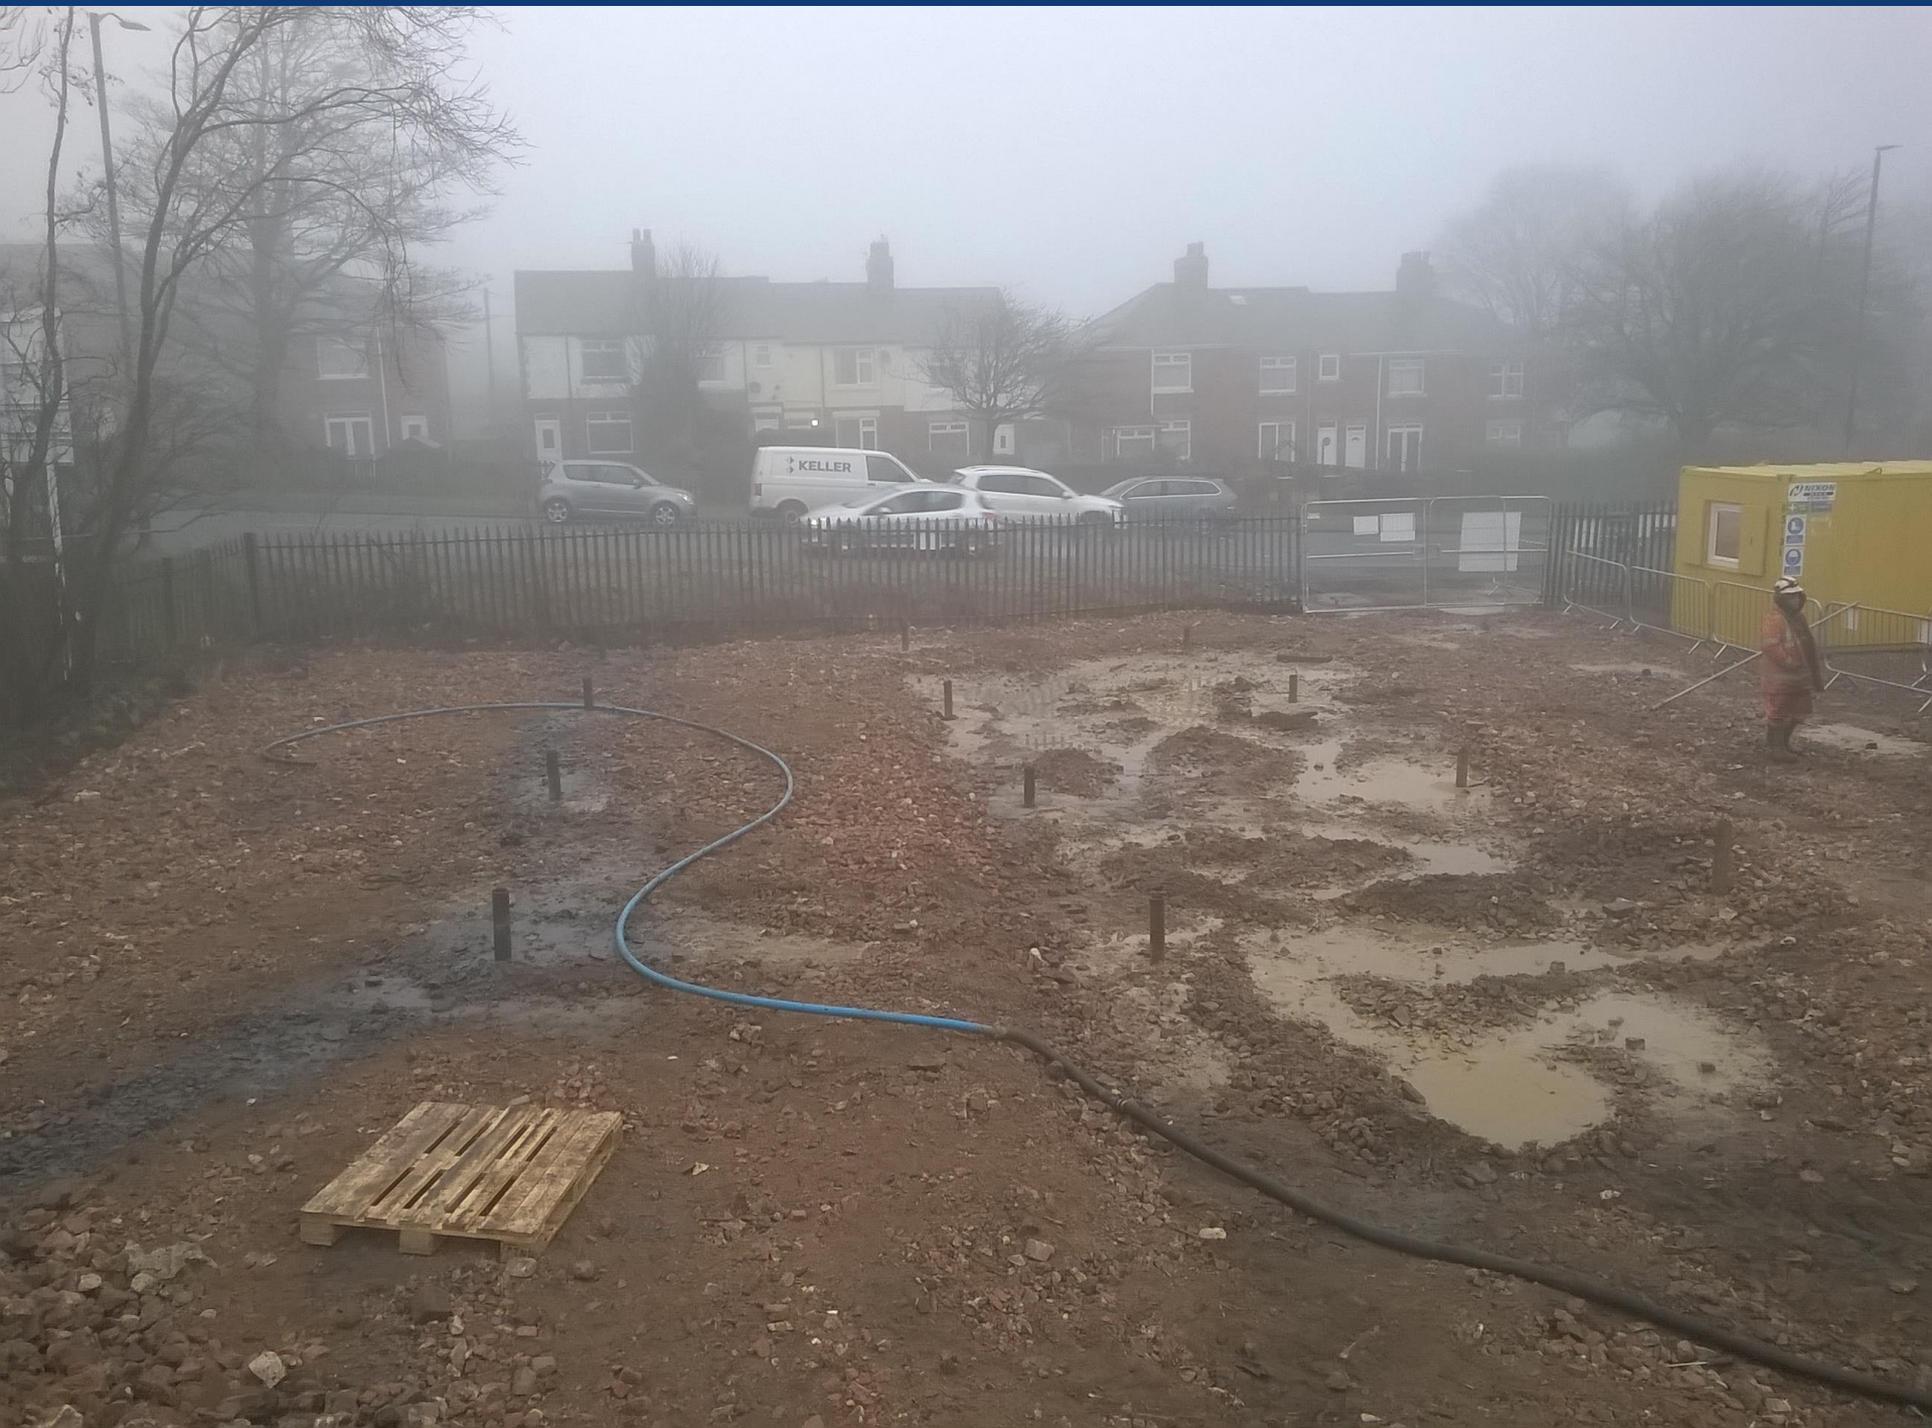
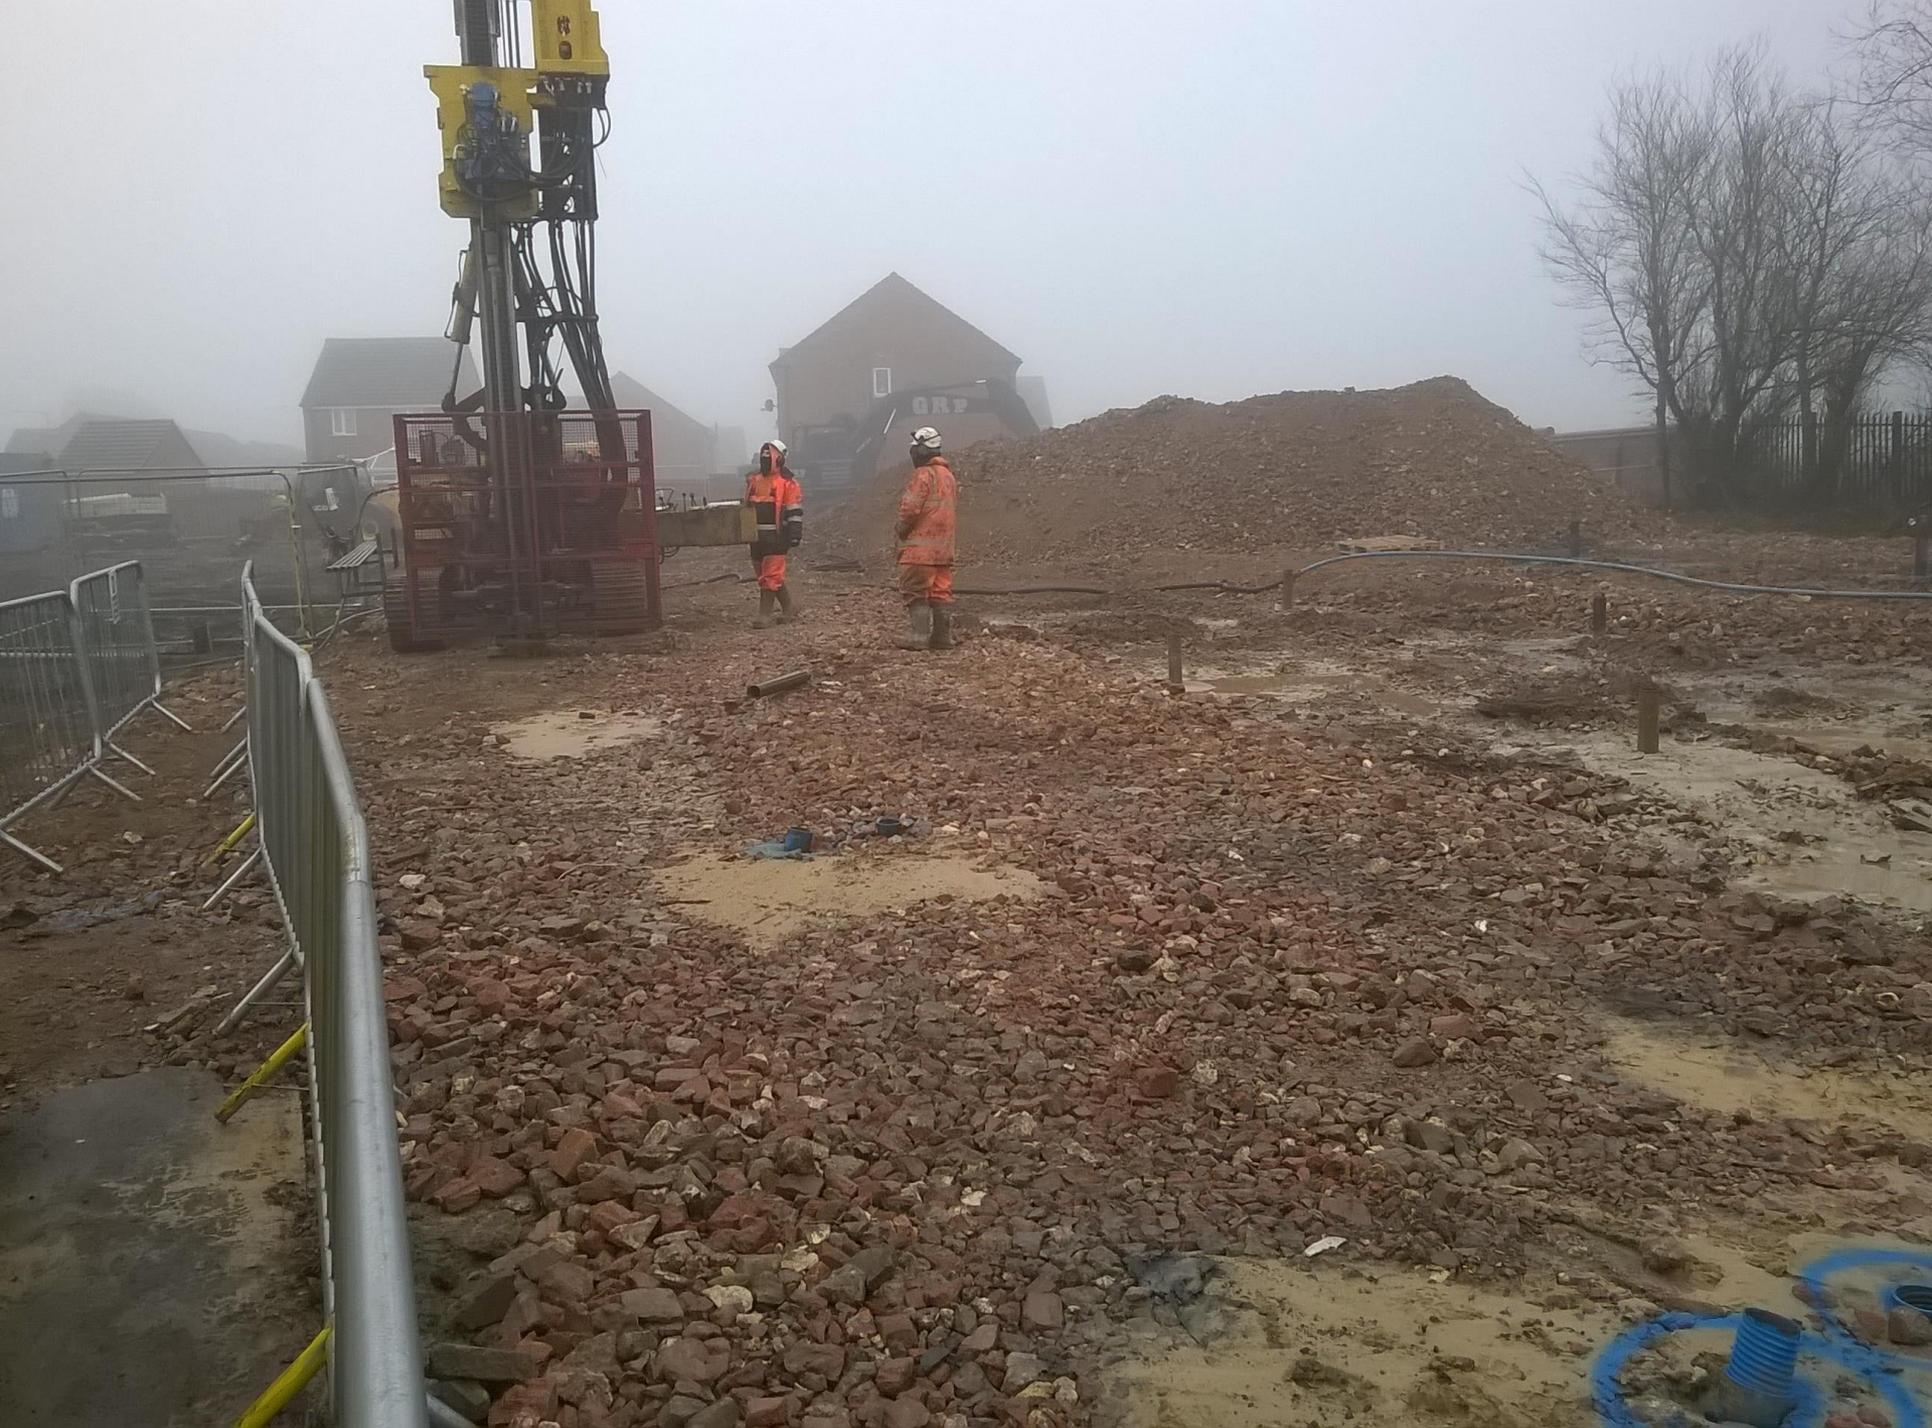
ANNFIELD PLAIN -GROUTING

- Mineworking identified within the high main seam below the site.
- Grouting was undertaken on a 4.25m square grid pattern beneath the buildings and a 6m grid beneath the roads.
- 157 boreholes drilled using a total of 811.5 tonnes of grout.
