The Hartley Colliery Disaster 1862

Norman W Jackson
FIMMM FNEIMME CEng EurEng
Past President of the Institute

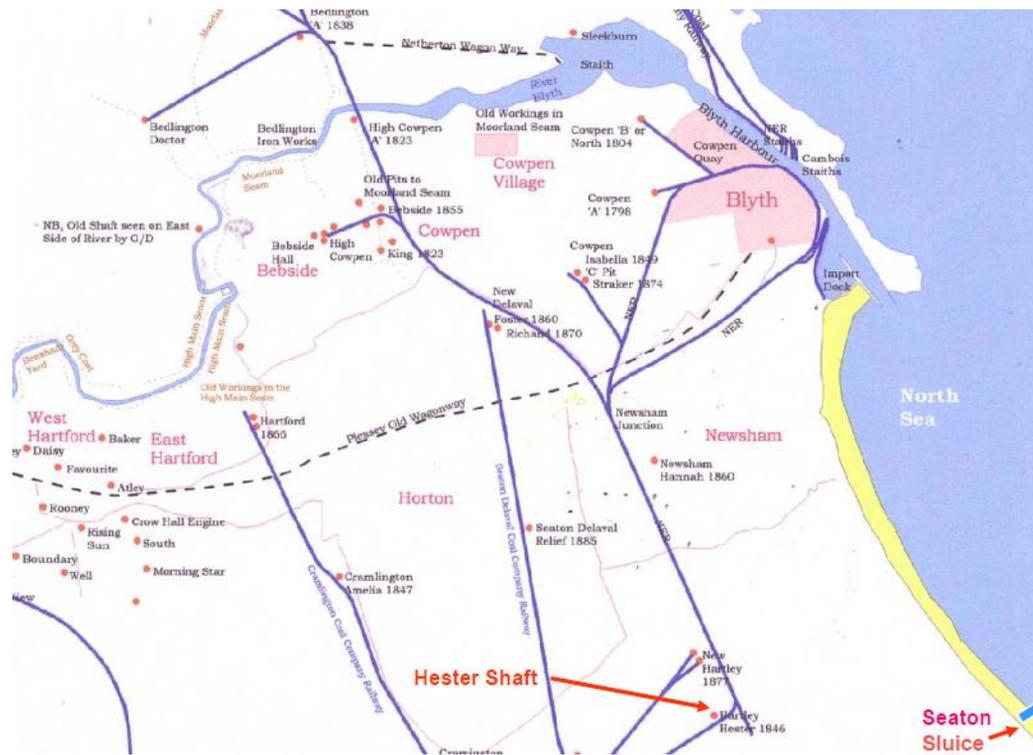
Figure 1: Positions of many of the local pit shafts that had developed from the coast inland.

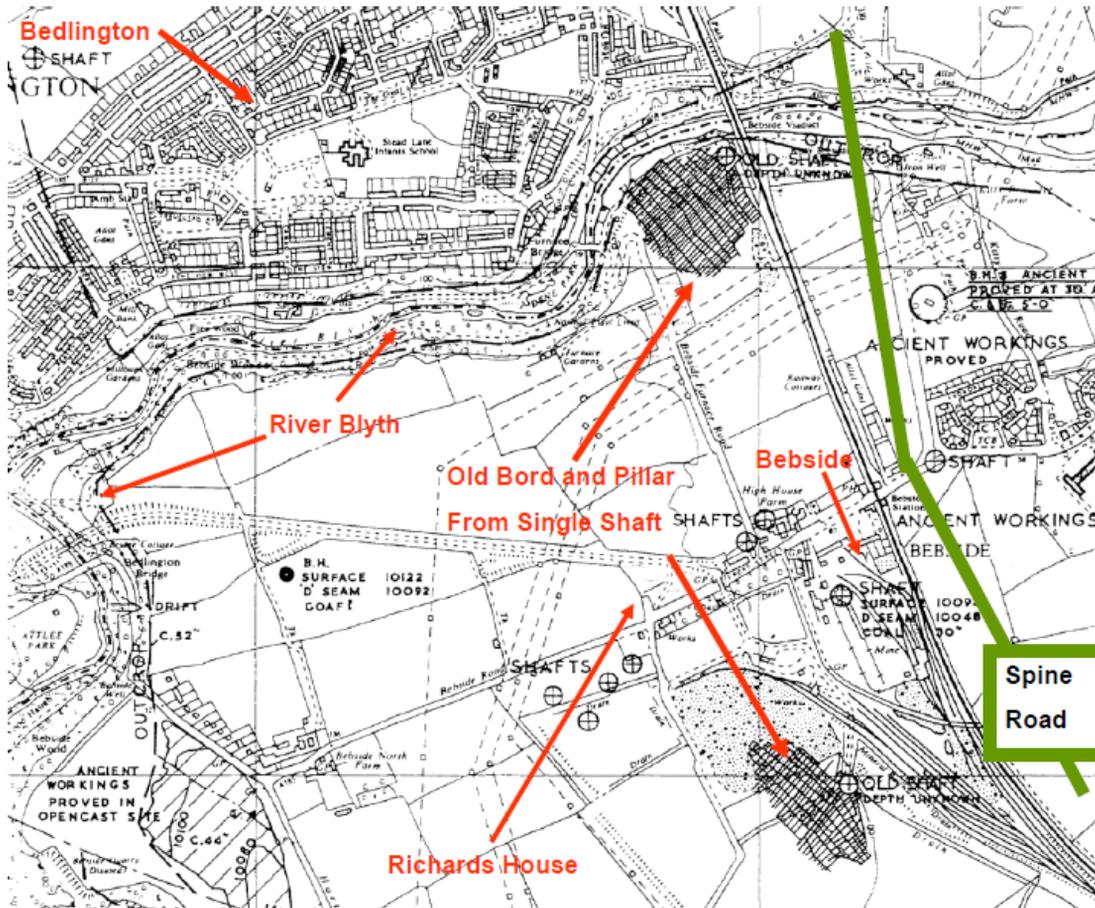
Figure 2: Map of actual workings from a single shaft.

Mining in Northumberland has been carried out since Roman times with records of workings existing in 1236 in the town of Blyth. These earliest records of local mining in England show the Moorland Seam was worked along and near its outcrop westwards through Cowpen to Bebside. Site investigation boreholes within the township of Blyth have confirmed the existence of unrecorded coal mining at shallow depth. Fig. 1 shows the positions of many of the local shafts that had developed from the coast inland. The location of the Hester shaft and the important port of Seaton Sluice help to identify the area. The area is on the coast some 12 miles north of Newcastle. The principal cause of the Hartley disaster is of course the well-known fact that there was only a single access to the mine which was common practice for the period. Records show that when Hartley disaster occurred 10 of the 11 mines operating in the locality were single shaft mines. This slide is an example of one of the earliest bord and pillar workings quite clearly from a single shaft access. Two sites have actual plans of the workings. They are located near Bebside and further to the North and banks of the River Blyth. Fig. 2. has the spine road superimposed to help in the orientation for those knowing Northumberland.

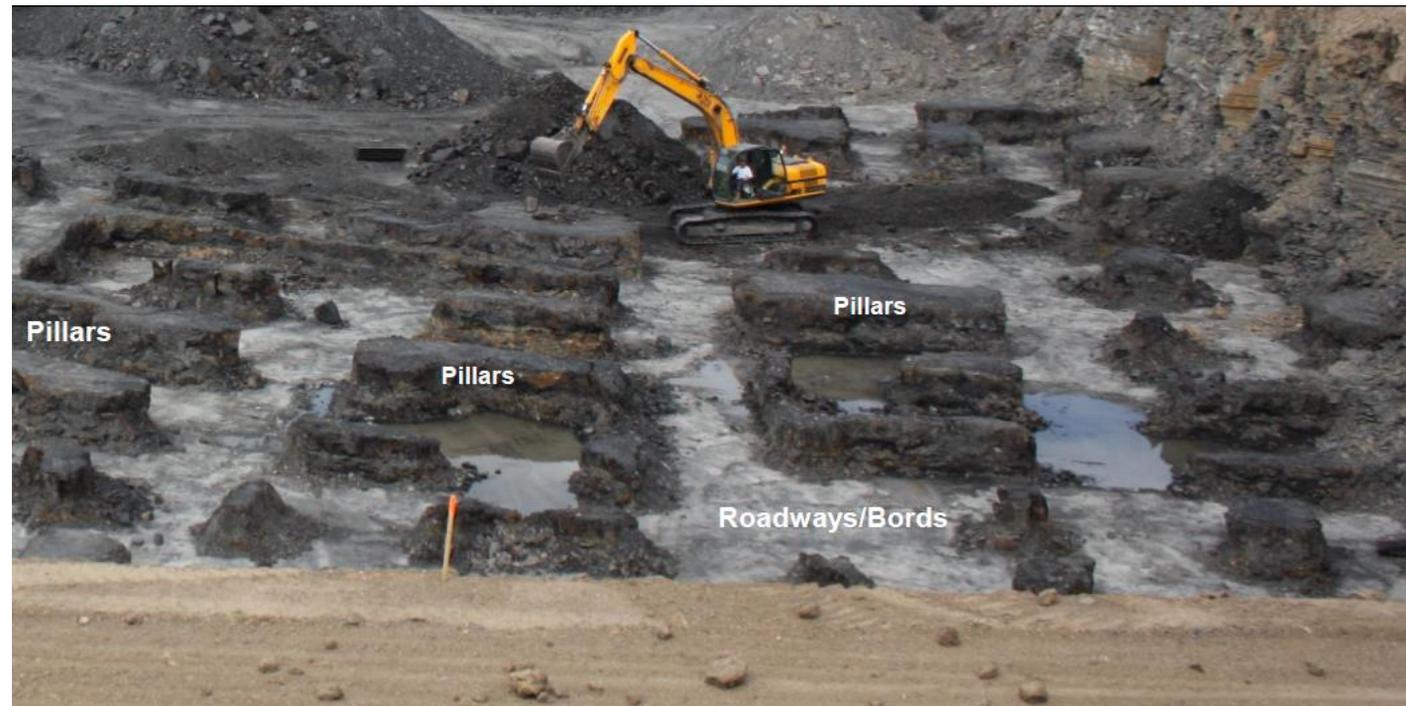
Figure 3: The high main seam at Ashington Portland Burn opencast mine clearly showing 10m below the surface the roadways formed though extracting coal the small pillars left support the roof.

For non-mining people we are now fortunate that opencast mining lets us look back at some of the early methods of mining just as it would have been at Hartley at the time of the accident. Fig. 3 is a photograph I took recently in the high main seam at Ashington Portland Burn site opencast mine site just North of Hartley. You can see quite clearly at very shallow depth some 10m below the surface the roadways which formed the coal extraction and the small pillars left to hopefully keep up the roof. The first reference to Old Hartley pits is made in the book History of Northumberland and this records the date of 1292. The location of these original mines is between the Briar Dene at Whitley Bay and the Seaton Burn at Seaton Sluice. National Trust at Seaton Delaval Hall now own much of the area. No record of the actual workings exists, but the plan extract shown in Fig. 4 indicates the positions of the various shafts that have been located over time.

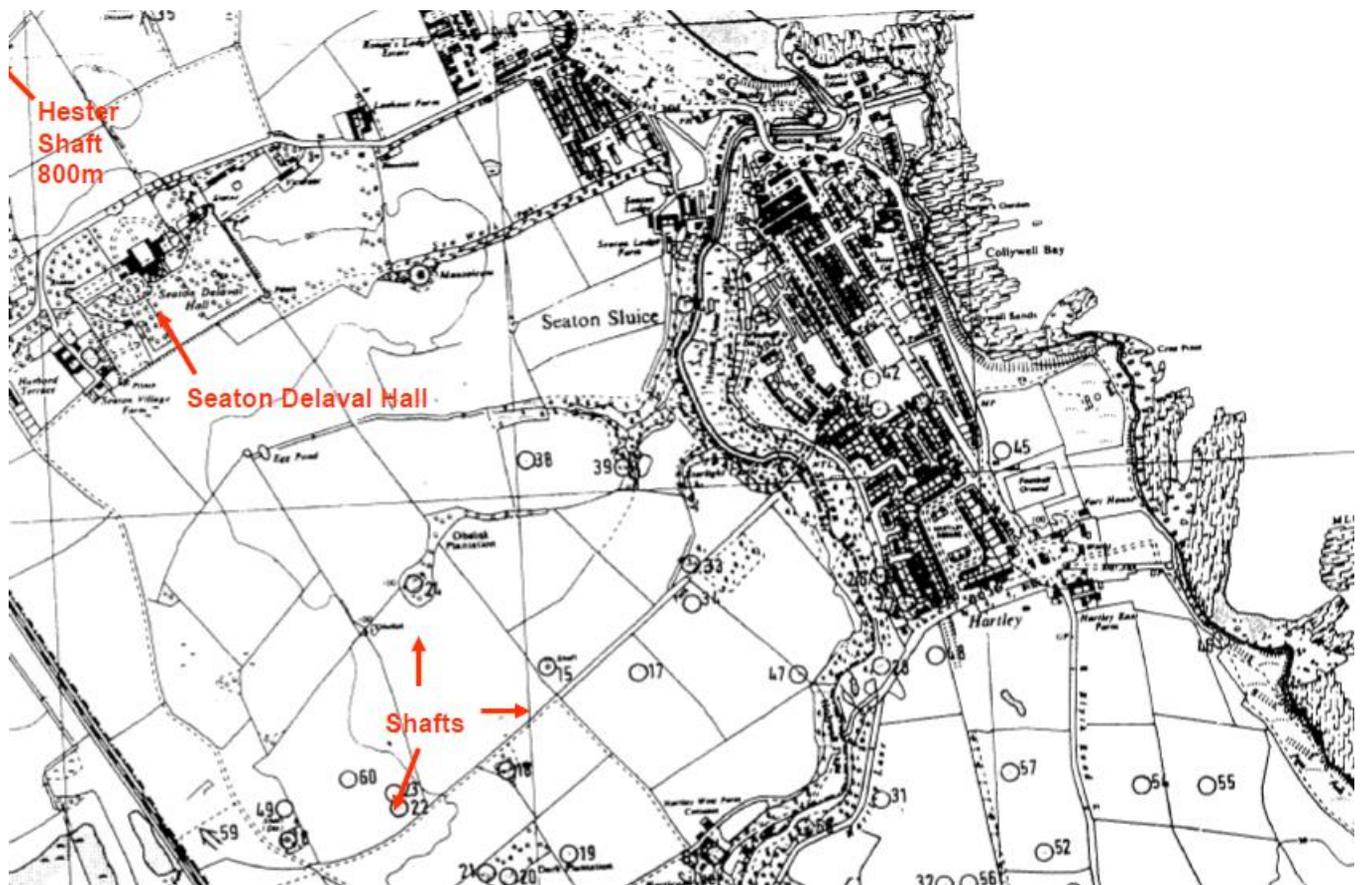
Figure 4: Map of the Hartley mine shafts.

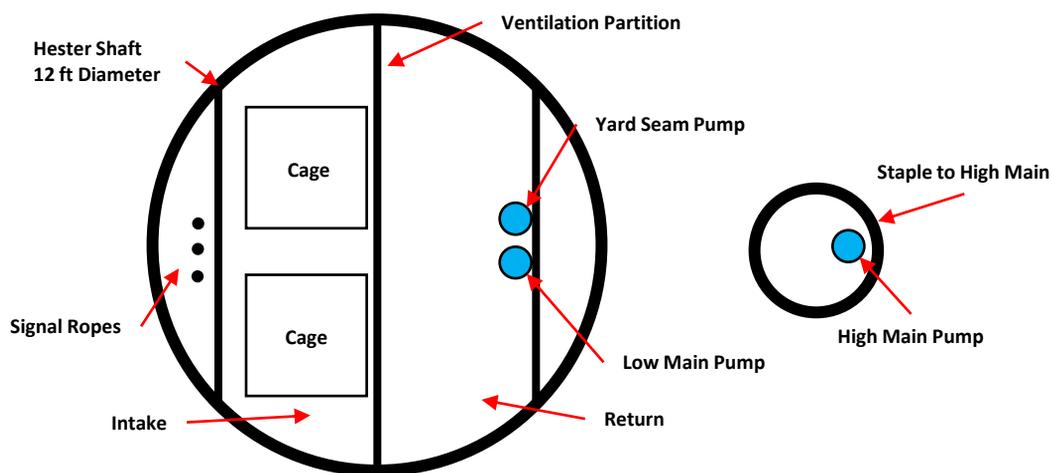
Figure 5: Plan view cross-section through the Main and Staple shafts.

A very sobering statement. Fig. 5 diagrammatically illustrates the general arrangements. The shaft was partitioned into two, separated by 3 inch wood planks to provide intake and return airways. The intake side contained the two cages which provided transport for men, materials and winding of coal. The return side incorporated the main pumping system for what was to become an extremely wet mine. In addition to the main shaft there was also adjacently a small staple shaft which was sunk to just below High Main seam utilised for pumping, but it was equipped with a small jack engine for access to that level. The means for communication within the main shaft and to the surface was three separate bell ropes connected to each of the three seams. These proved important later during the rescue of the men trapped in the cage. Whilst there is no description in any of the historic documentation of additional supports or buntings in the shaft, obviously, they were present to support the cage guides and the pump ranges. The 1852 Inrush in the period following the shaft sinking work was difficult with water proving a major problem like conditions that had caused the closure of the old collieries. On 14th of February 1852 an immense feeder of water inundated the mine. Like the recent incident in Wales the mine had intersected some old workings which were filled with a vast amount of water. The existing pumping system was overcome, it had proved totally inadequate and it was extremely fortunate that before the shaft was flooded that the men and horses working underground at the time were managed to be rescued. No doubt a very close shave.

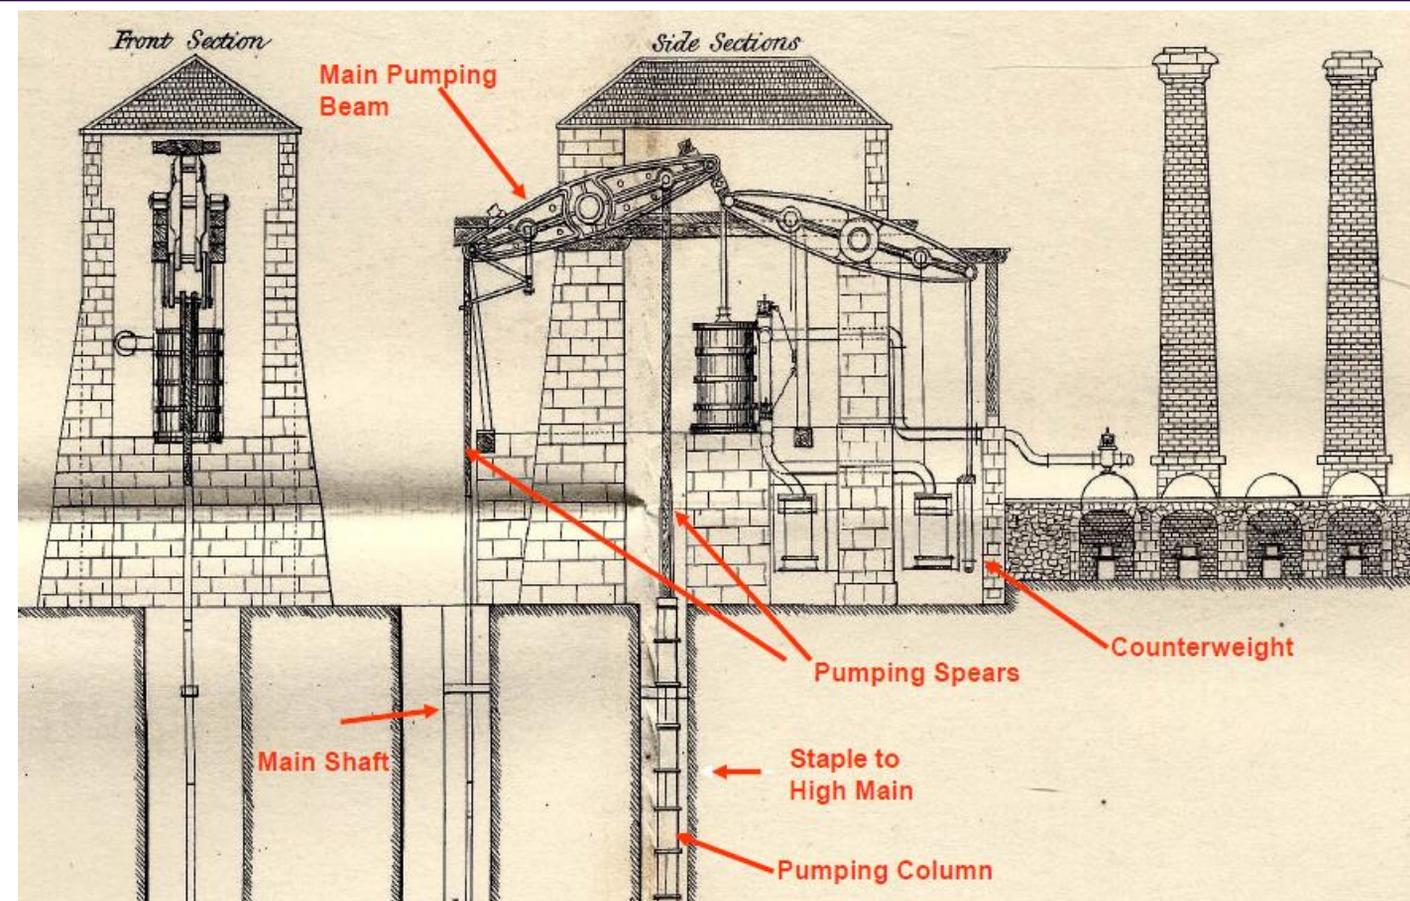
Figure 6: Schematic of the new pump system at Hartley Colliery in 1862.

At the time of this latest inrush coal was in tremendous demand and the mine owners immediately commissioned the installation of a new powerful pump. This was a huge machine of its time powered by a 400hp condensing steam engine. We are fortunate at the Institute to have a copy of the original drawing of the completed installation depicting the system before and after the accident. I have placed an enlarged copy of this drawing in the exhibition of Hartley artefacts in the library. It is reputed that when pumping at full capacity it could handle 1,500 gallons per minute. The obvious concern to present day mining engineers would be that there was no spare pump and therefore how could proper maintenance schedules be carried out. It is essential to have a broad understanding of the workings of the system to be able to picture what went wrong and I will give you brief resume. Figs. 6 and 7 show the surface and initial shaft arrangements:

- Pumping beam and counterbalance a single beam operating three pumps
- 35 feet long 42 tonnes in weight
- Effectively a 3 stage pump low main to yard seam.

- Yard to High Main and High Main to surface via the pump staple
- The pump rods were made of hard wood, 12 inch square and 21 feet long initially and the middle and low set 10 inch square. They were made of memel, which is imported Polish oak, British oak being in short supply due to the demands of warships. They were joined together to form a column either by iron plates but possibly chains to allow some flexibility. It was calculated that some 55 tons of weight was suspended from the beam.

- The pump rods or spears were classified in two ways. When they were within the pump barrels they were obviously in water and known as wet spears.
- Where they were outside the barrels mainly at the top section of the shaft they were known as the dry spears. Obviously here they were open to the elements and the changes in temperature always present in a mine shaft.

- The pump barrels cast iron and riveted plate. The lower pumps 24 inch diameter and the upper set 30 inch diameter. They were huge and heavy pieces of equipment.

- The pump action was a simple plunger mechanism with the water on the downward stroke pushing open the valves.
- The weight of water was closing the valves on the upward stroke. The slide shows simplified bucket system on the left showing the overflow arrangement between the lower low main and Yard Seam mid shaft pump. The right side indicates the transfer arrangement.

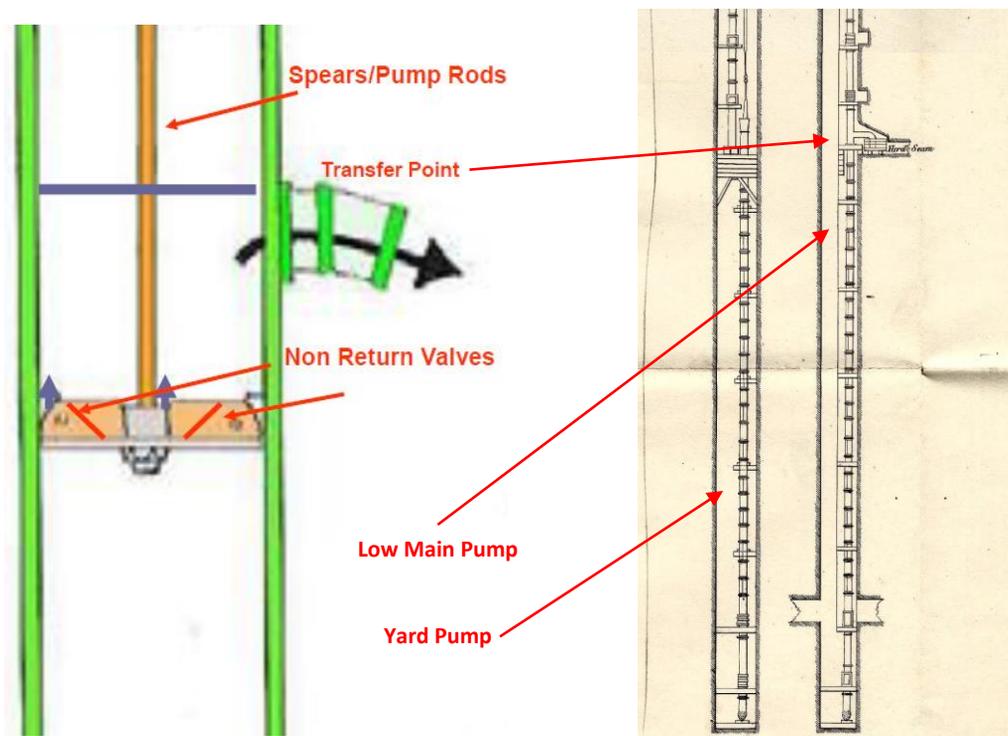
Figure 7: Schematic of the pumping system within the shaft.

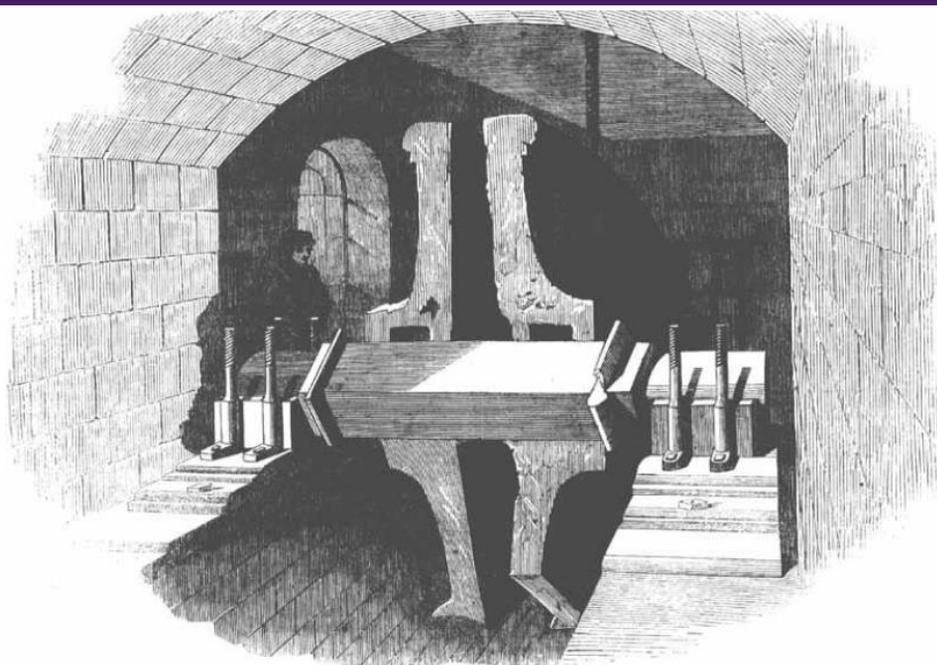
THE BROKEN BEAM OF THE PUMPING-ENGINE.

Figure 8: Drawing of the remains of the broken Main Pumping Beam within the pumphouse.

Some of the evidence makes very harrowing reading with many of the aspects of the injustice of the time relating working conditions very apparent. The immense bravery of the attempted rescuers provides sobering thoughts. In summary the verdict reached reads “As a result of the engine beam breaking, falling into and blocking the shaft, the men died from inhalation of gas being entombed in the Yard Seam as all access to escape was cut off”. The jury also recorded their views on three issues:

- All collieries should have at least a second shaft or outlet to afford workmen a means of escape.
- In future all beams of colliery engines should be of malleable metal instead of cast metal.
- The jury take notice with admiration the heroic courage of the viewers and others who devoted their skill and energy to do everything possible in the attempted rescue.

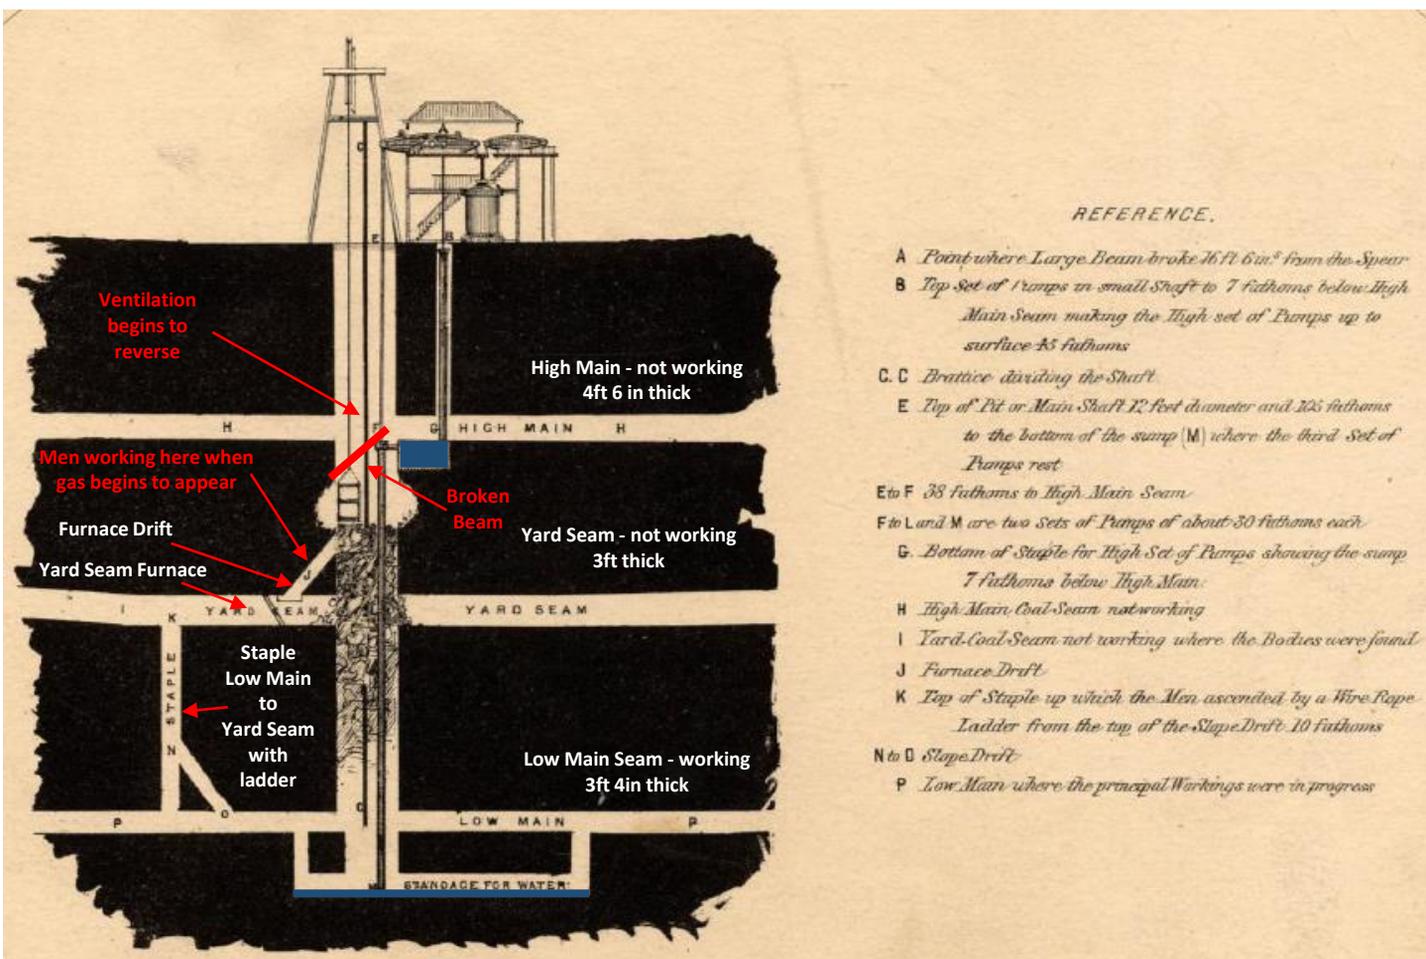
Figure 9: Section depicting the accident.

I would like you now to picture the additional wood and iron in a highly congested 12 feet 6 inch shaft. Installation and access of the pumping equipment was enabled by an auxiliary jack engine winch which was very important in the rescue attempts that were to follow. On 16th January 1862 it was a normal winters day. The main change in shift was taking place and as was normal practice the men and boys changed over roles underground and as a result twice the normal number were present at this time. The back shift had gone down and the foreshift still in the pit, as we now know, totalling over 200 men. Some 17 men had been wound to the surface and eight men were in the cage, four in the top deck and four in the bottom, when suddenly without warning the main pump beam snapped in two (Fig. 8) and immediately was pulled down the shaft. I would like you to imagine the picture of devastation that beam disappearing down the shaft would present, the noise of breaking timber and falling iron as the shaft partition and pumping system was carried away. The people at the shaft top and winding engineman's initial thoughts were for the eight men in the cage with the winder coming to an immediate stop as the beam hit the cage. It transpired that half the main beam, some 21 tonnes had met the cage between the High Main and Yard Seam about 30 feet below the High Main, completely blocking the shaft with debris (Fig. 9).

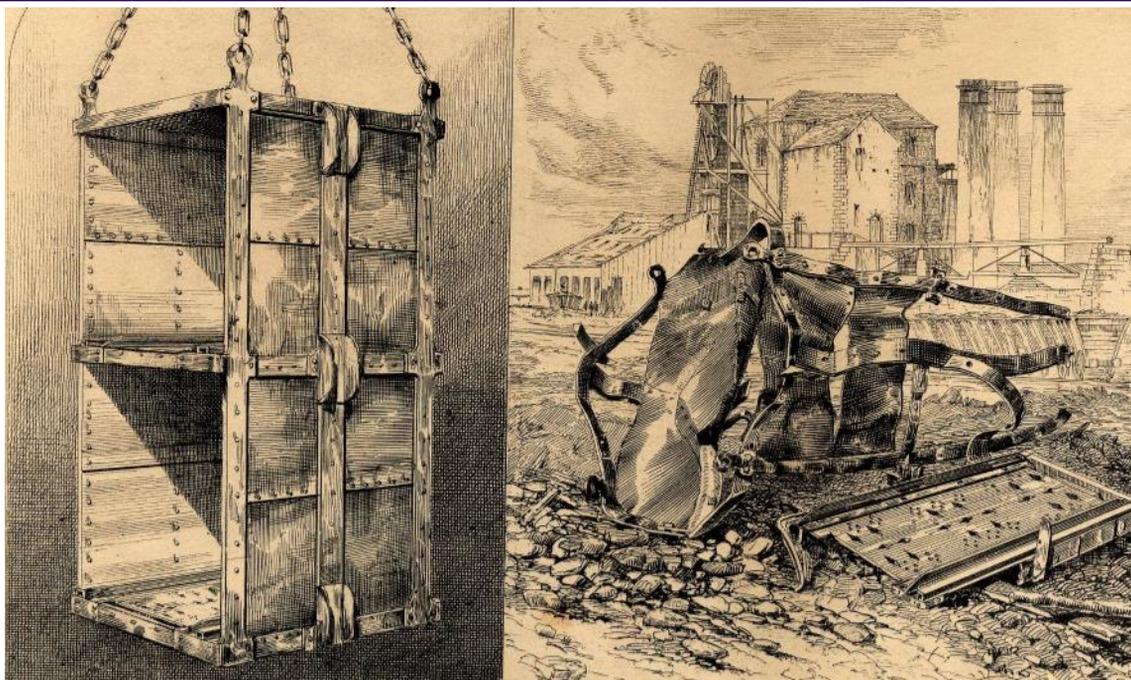
Figure 10: The cage used at Hartley Colliery before (left) and after (right) the accident.

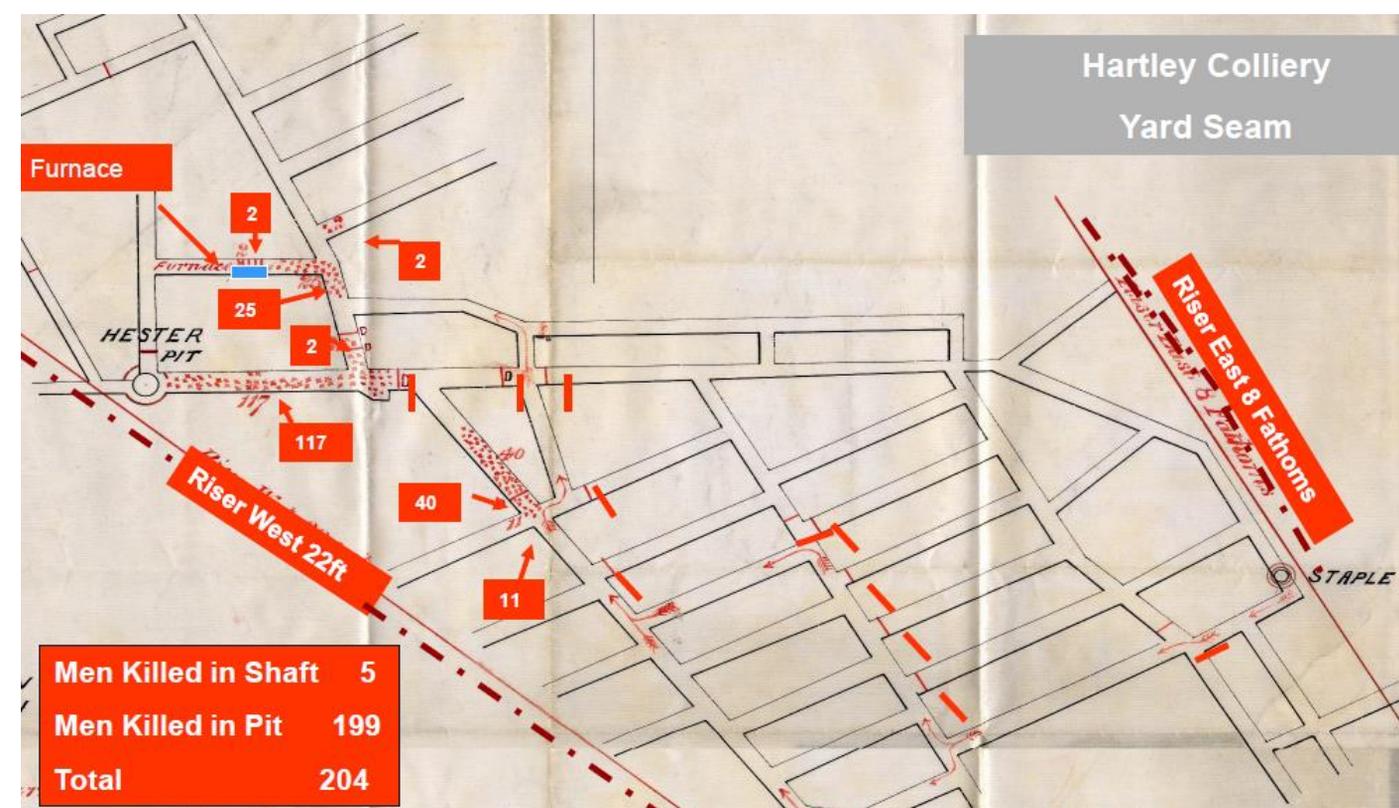
Figure 16: The accident plan.

During the day, work was sufficiently advanced for the sinkers to make a small entrance into the furnace drift, but they found the gas so strong it was some time before they could affect entry. Three miners: Bill Adams from Cowpen, Rob Wilson and Thomas Cousins from Backworth took over and entered the furnace drift. They found evidence of men having put out the furnace fire and forced their way into the drift and had begun to clear a way out. The would-be rescuers then proceeded into the drift and soon the worst fears were confirmed: all men and boys - 199 of them were found dead. The plan used at the inquest confirms the positions where they were located (Fig. 16). The various messages found confirmed the events that had taken place.

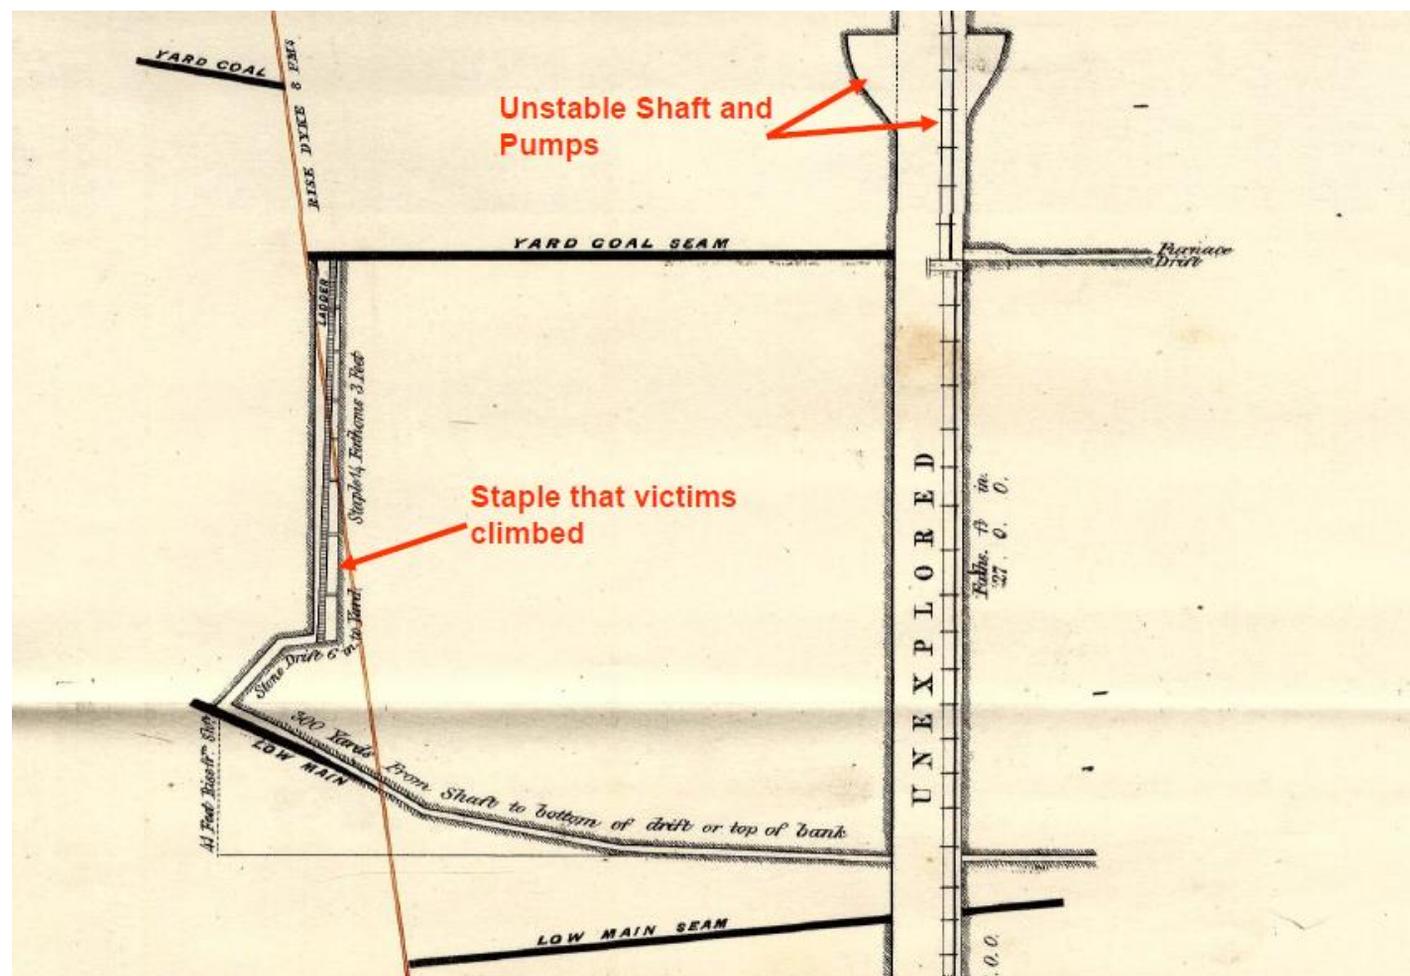
Figure 17: The situation in the mine on Thursday the 23rd and Friday the 24th of January 1862.
